Bummer Creek Meadow Restoration

T. 14 S., R. 7 W., Sec. 31

Meadow Site Description – Mary’s Peak Resource Area, Salem District BLM

Landmark Name: *Bummer Creek*

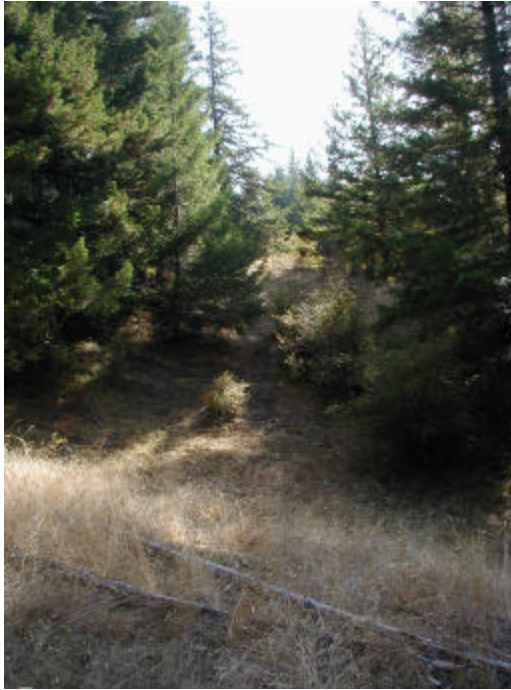
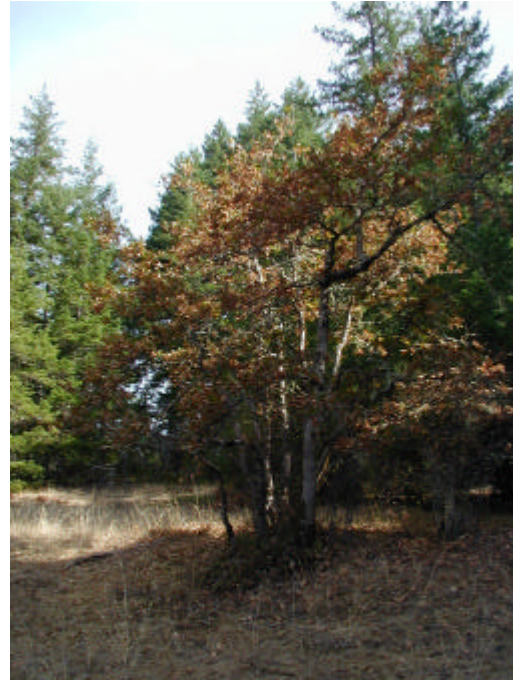
This is a dry site dominated by grass and shrubs, with a few Oregon white oak and madrone at the fringes of the meadow.

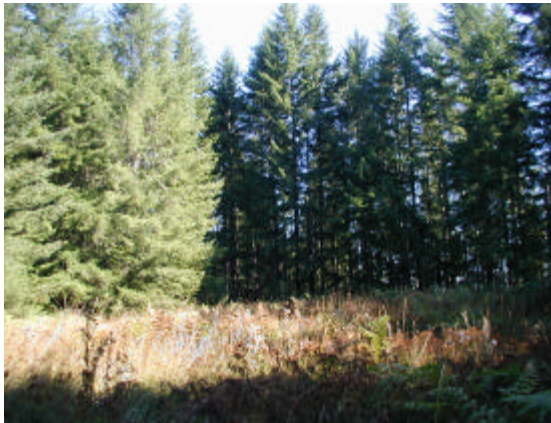
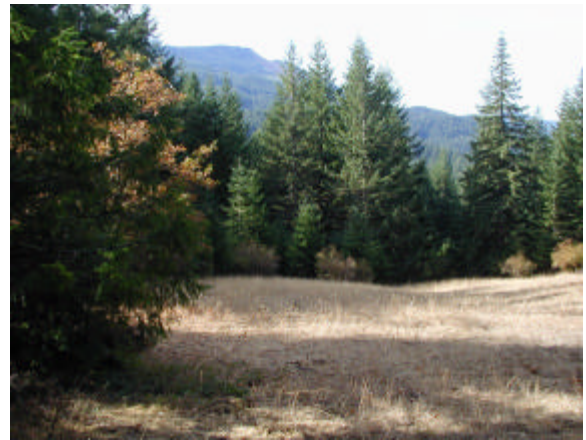
Conifer invasion: Conifer encroachment has diminished its size, with most edge trees est. at 15-30 years. However, the interior is so dry, it supports little grass, mostly racomitrium moss, and will unlikely support Conifer at all. Conifer invasion is most evident along the southeast edge and a stringer of trees that have established in the center of unit.

Conifer encroachment has diminished the size of the meadow and decreased the vigor of hardwood trees on the site.

Recommended treatments: Cut Conifers <10” DBH to open margins back up. Lop slash.
